CIA IMAGERY ANALYSIS DIVISION

TANK/ASSAULT-GUN UNITS

TA-TUNG, CHINA

(40 05N-113 17E)

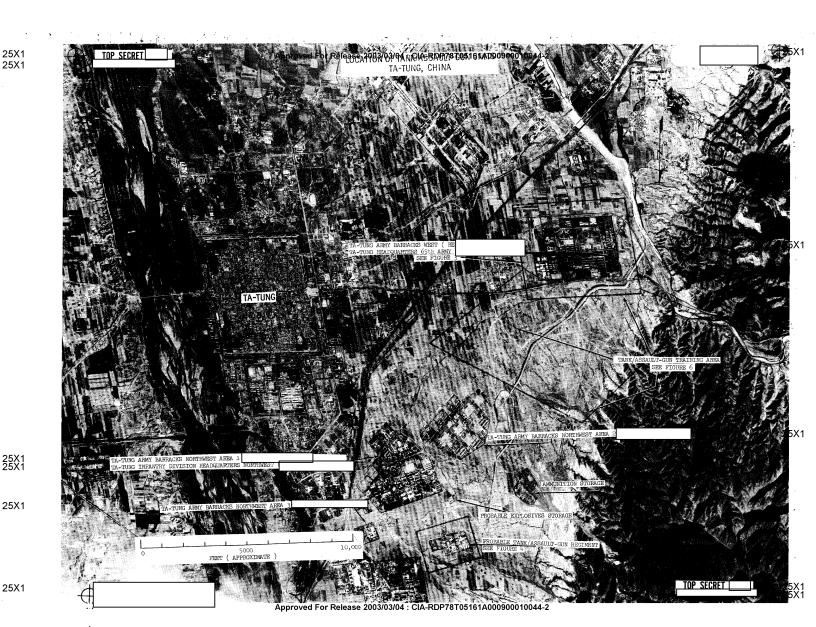
ed For Release 2003/03/04: CIA-RDP7 T0516 A000900010 044-2 TA-TUNG ARMY BARRACKS WEST (BE N TA-TUNG HEADOUARTERS 65 th. ARMY(TA-TUNG, CHINA 25X1 25X1

Ab. Administration and barracks area

- 3 Two-story administration buildings
- 11 Two-story barracks 2@ 90' X 40' 9@ 190' X 45'
- 1 Heat/power plant

- 1 Support building
- 3 Two-story barracks/administration buildings 190' X 45'
- l Messhall
- 4 Two-story possible officer's quarters 95' X 45' (these are in groups of two arranged in an "L" shape)
- 1 Athletic field

Ac. Barracks area

- 2 Administration buildings
- 5 Two-story barracks
- 2 Messhalls
- 1 Heat/power plant

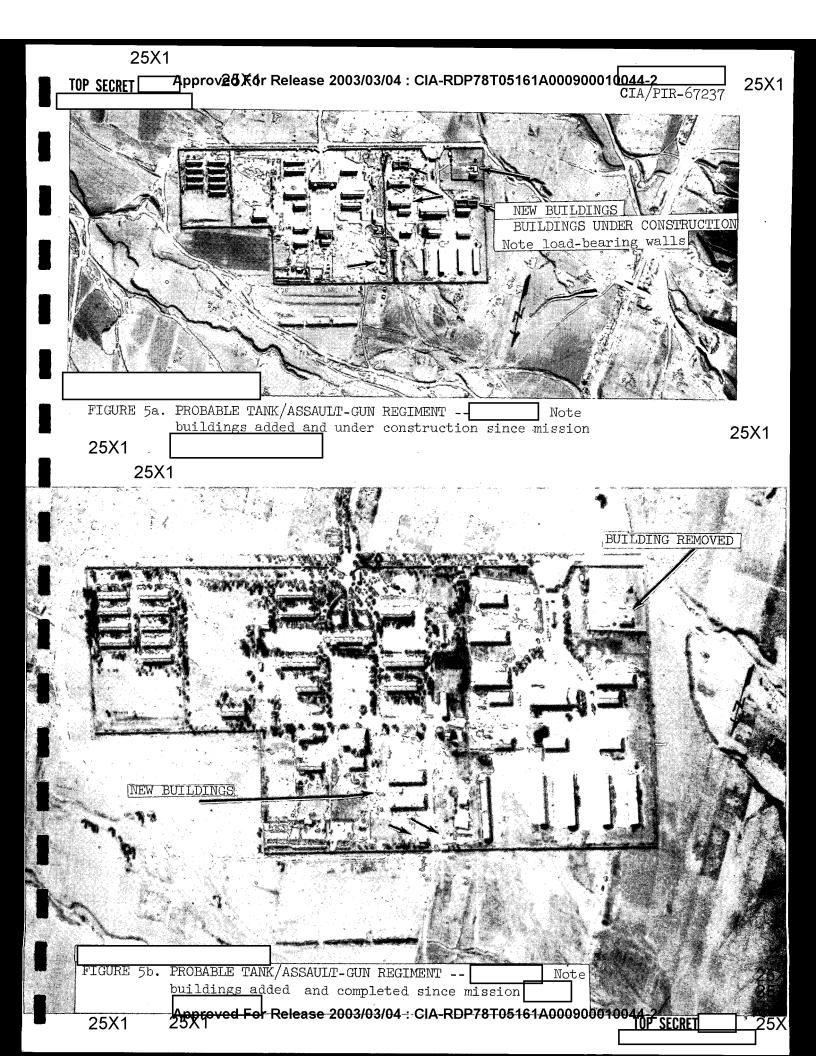
Approved For Release 2003/03/04 CLA RDP78T05161A000900010044-2 CIA IMAGERY ANALYSIS DIVISION CIA/PIR-67237	25
25X1 25X1	<pre>1 Heat/power plant 4 Vehicle service ramps 1 Walled administration area containing an administration building, 2 support buildings and a possible communication tower. (A small building first observed on coverage was removed on coverage.)</pre>	25
25X1	coverage one armored vehicle shed and one vehicle shed, each with thick load-bearing walls, were observed under construction. On coverage these buildings and two additional maintenance buildings had been completed and two new maintenance buildings were under construction. coverage all buildings were complete.	25 25
L.	Subcaliber weapons firing ranges Two subcaliber weapons firing ranges are located on the north side of the probable regimental area.

The limited degree of earth scarring observed on these ranges indicates a low-level of activity. The west range

may be abandoned.

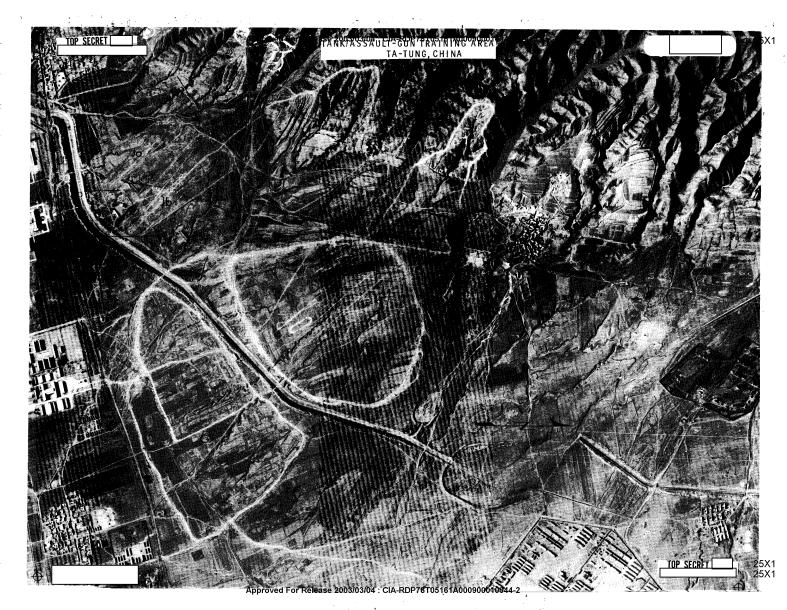
Ap	Deproved For Release 2003/03/04 : CI A-RDP78T05161A000900010044-2 TOP SECRET	0.51/4
			CIA IMAGERY ANALYSIS DIVISION CIA/PIR-67237	25X1
25X	1			
			TANK/ASSAULT-GUN TRAINING AREA 40 05 30N-113 13 30E	
FUN	CTION	IAL AR	REAS (See Figures 2 and 6)	
	. G.	Trac	ked-vehicle driver-training courses	
25X1			Three areas of closed-circuit, tracked-vehicle, driver-training courses are observed. Each contain a number of interspersed circuits.	ıg
		[One cargo truck and one unidentified vehicle were observed on coverage. No other vehicles/equipment were observed.

J.	Tank	x/assault-gun moving target firing ranges	
***			Range "Ja" has 3 to 4 firing lanes and one moving-target run.	
25X1			Range "Jb" has 4 to 5 firing lanes and one "V" shaped moving-target run. Six canvas covered provable tanks/assault-gun were observed on coverage.

L.	Subc	caliber weapons firing range	
			Range "La" appears to be inactive. No earth-scarring or activity was observed on any coverage.	
*		- 14	Range "Lb" is active. One possible tank/assault-gun was observed near the firing butt on overage.	25X1
			Range "Lc" is active. Five probable tanks/assault-guns were observed on the firing line on coverage.	
IND	CATI	ONS C	OF LEVEL OF ACTIVITY	25X1
is			els of ground scarring in the training area reveal that training performed year around with the greater activity during the od.	.ng
